## NEAREST

Integrated observations from NEAR shore sources of Tsunamis:  
towards an early warning system

### D15b: Annex

**Buoy Operation report  
(October, 17 – 21, 2007; November, 23- 27, 2007)**

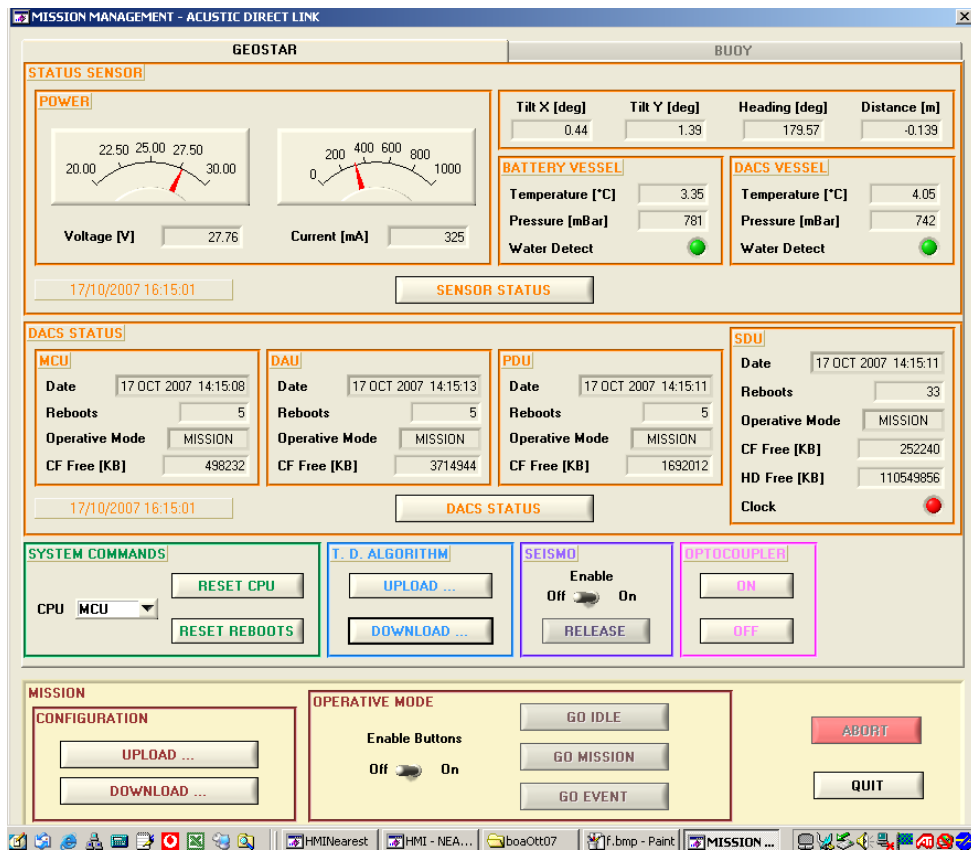
Fig. 2 - GEOSTAR DACS status answer

| 14:15 | DACS status command send from surface unit and answer correctly received |

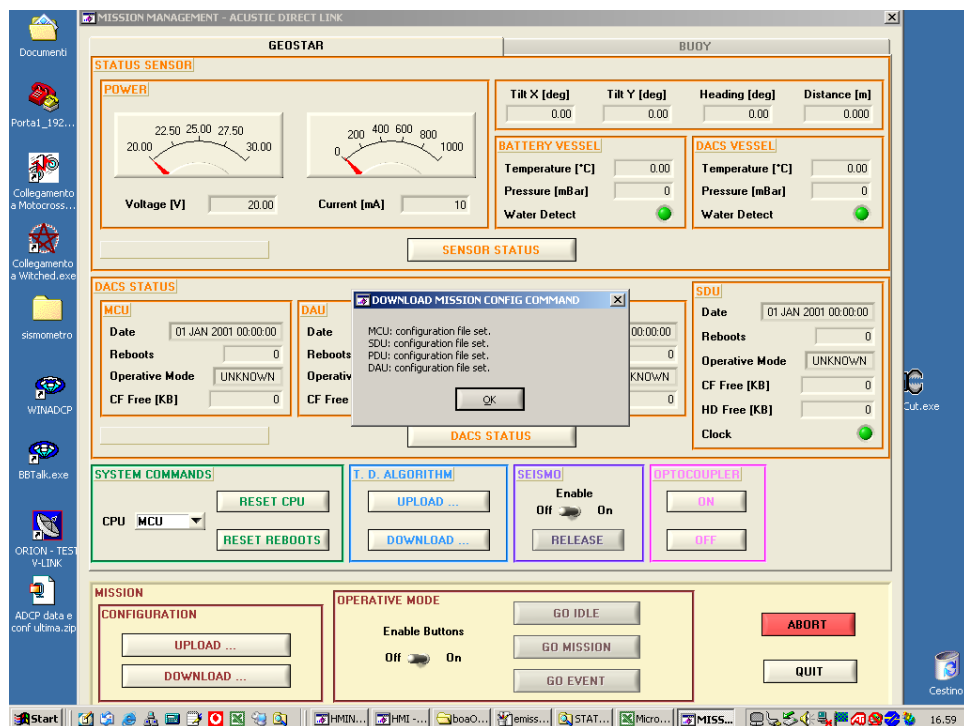
Fig. 4 - Configuration file correctly received by GEOSTAR

| 14:50 | Setup of the new configuration file for GEOSTAR mission, according to the defined procedure (STA/LTA threshold) and real time instructions from INGV site in Rome (periodic messages delivery):<br>STA/LTA threshold set to 12.0<br>Periodic messages are enabled with release time of one every 6 hours (as defined at the start of the mission in August)<br>Event message are enabled.<br><br>The configuration file is saved and re-opened from the HMI interface in order to check that it was correctly setup. Parameter of configuration were checked with Tecnomare engineers.<br>According to the defined procedure,<br>the command GO IDLE was sent to GEOSTAR and it correctly answer;<br>Inquiry to retrieve DACS status (all board were expected to in idle mode):<br>GEOSTAR correctly answers;<br>Configuration file sent to GEOSTAR: GEOSTAR correctly answers;<br>Sent "reset MCU" command to GEOSTAR: GEOSTAR correctly answers; |

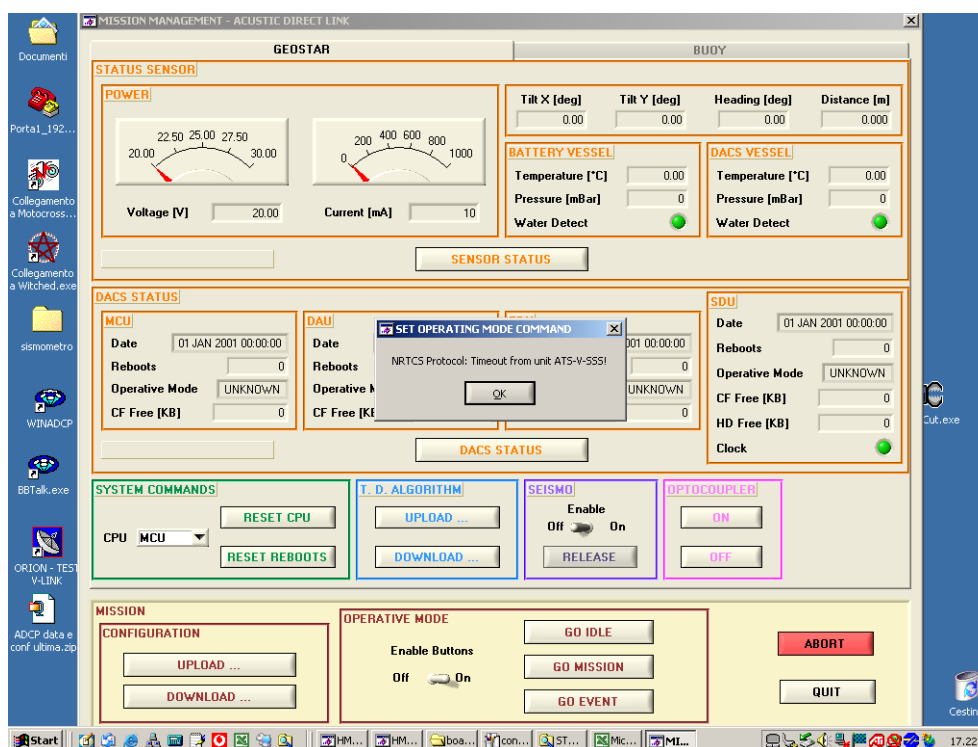
Fig. 5 - Time out received indicating no answer from GEOSTAR acoustic modem

| 15:22 | Time out from ATS V SSS message received, no acoustic answer was hear |
| 15:26 | Time out from ATS V SSS message received, no acoustic answer was hear |

| | No more messages from GEOSTAR ATS V USS unit to any command sent since 15:00 UTC were received. |

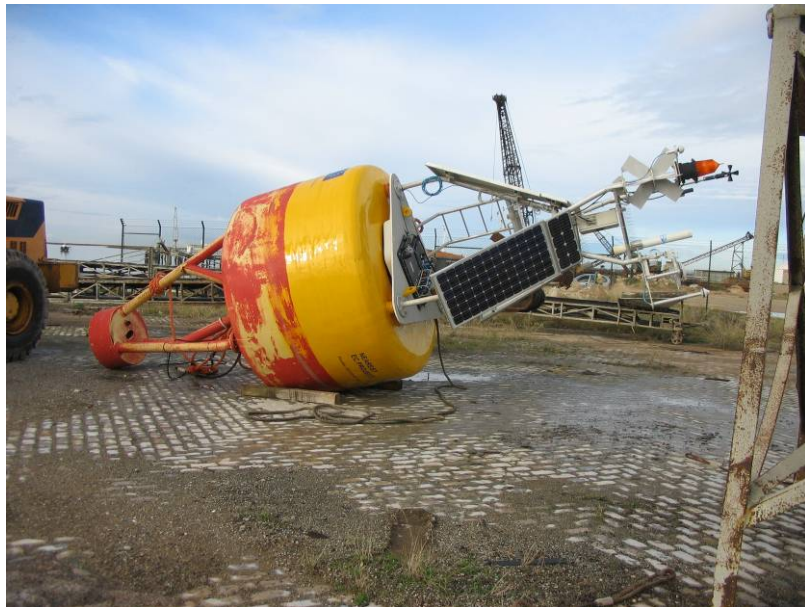
**Fig. 6 - The NEAREST buoy in the dock in Faro (November, 23<sup>rd</sup>)**

On November 23<sup>rd</sup> INGV staff reached the Faro dock where the buoy was temporary stored after the recovery on sea (fig.6) .

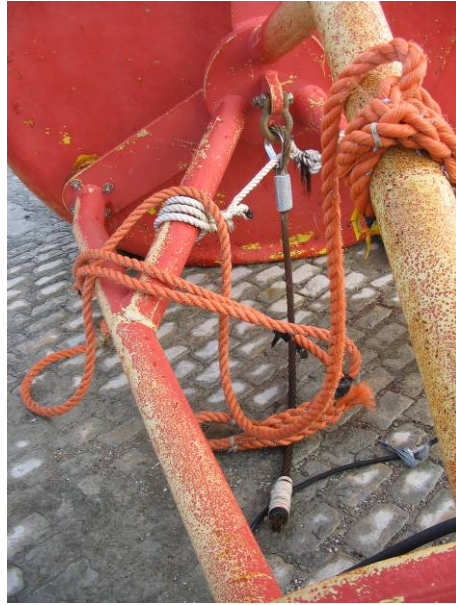
**Fig. 7 - The stainless steel cable; detail of the bottom of the mooring system of the buoy.**

| 13.00 | Buoy on the jetty. The next action planned has been the transport of the boa from Lagos to Faro inside the warehouse that we have used before for the OBS storage.<br><br>The visual inspection of the cable suggests that it was cut al the upper side of the ballast weight; the cutting looks very sharp. Possible causes started to be investigated. |

**At a visual inspection the stainless steel cable attached to the bottom of the buoy seems to be truncated in the proximity of the bottom ring of the buoy (**

**Fig. 7).**

The stainless steel cable, the electronic box of the buoy and all satellites antennas were shipped to Italy. The buoy was stored in the warehouse.

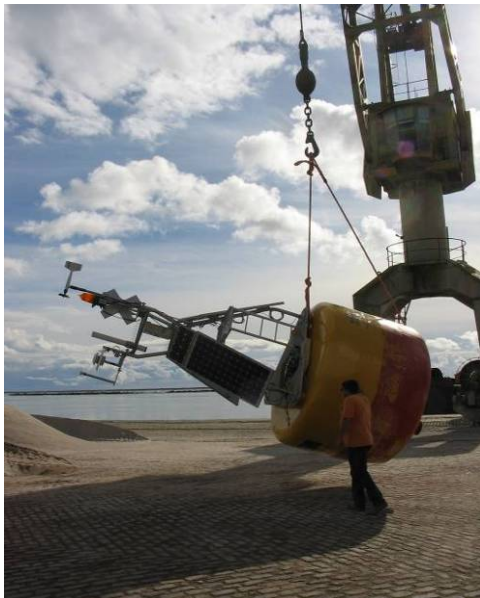
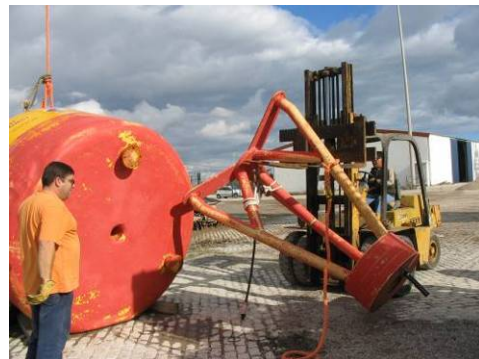
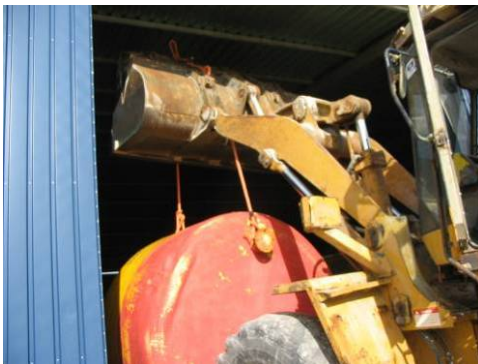
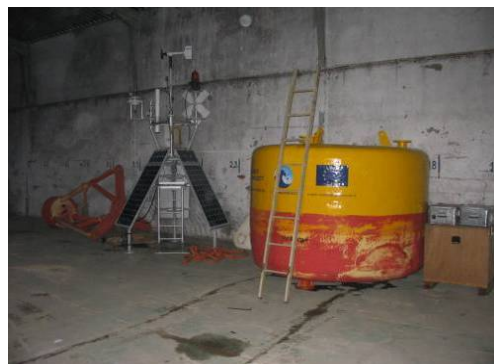
**Fig. 8 - Operations for disassembling and long term storage of the buoy**

The buoy was disassembled with the help of local staff and the use of the dock crane, a fork lift and a caterpillar. The electronic case and satellite antennas were removed, packed and prepared to be shipped to Italy.
